# *Kailas Cheriyan*

## Master Thesis

# Structural and Fatigue Analysis of a Type C tank Vessel at Class Renewal No IV

Type-C Inland Vessel ; Tanker

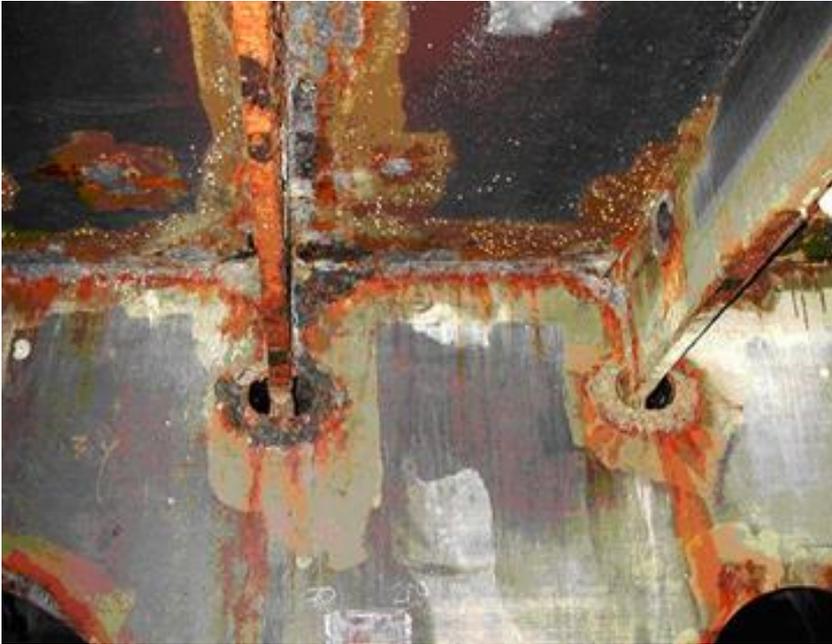
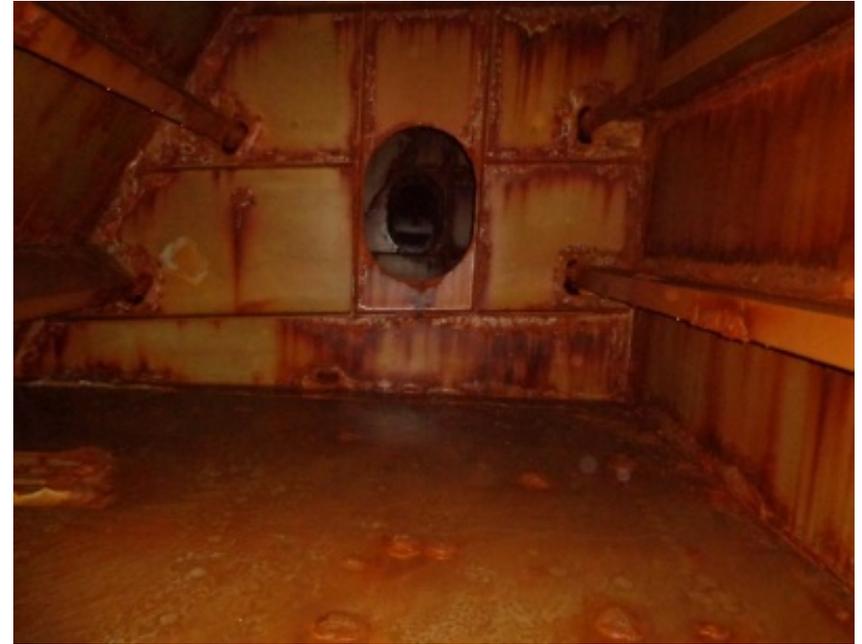
## Corrosion Affected Areas

Ship structural defects in the form of material wastage (corrosion).

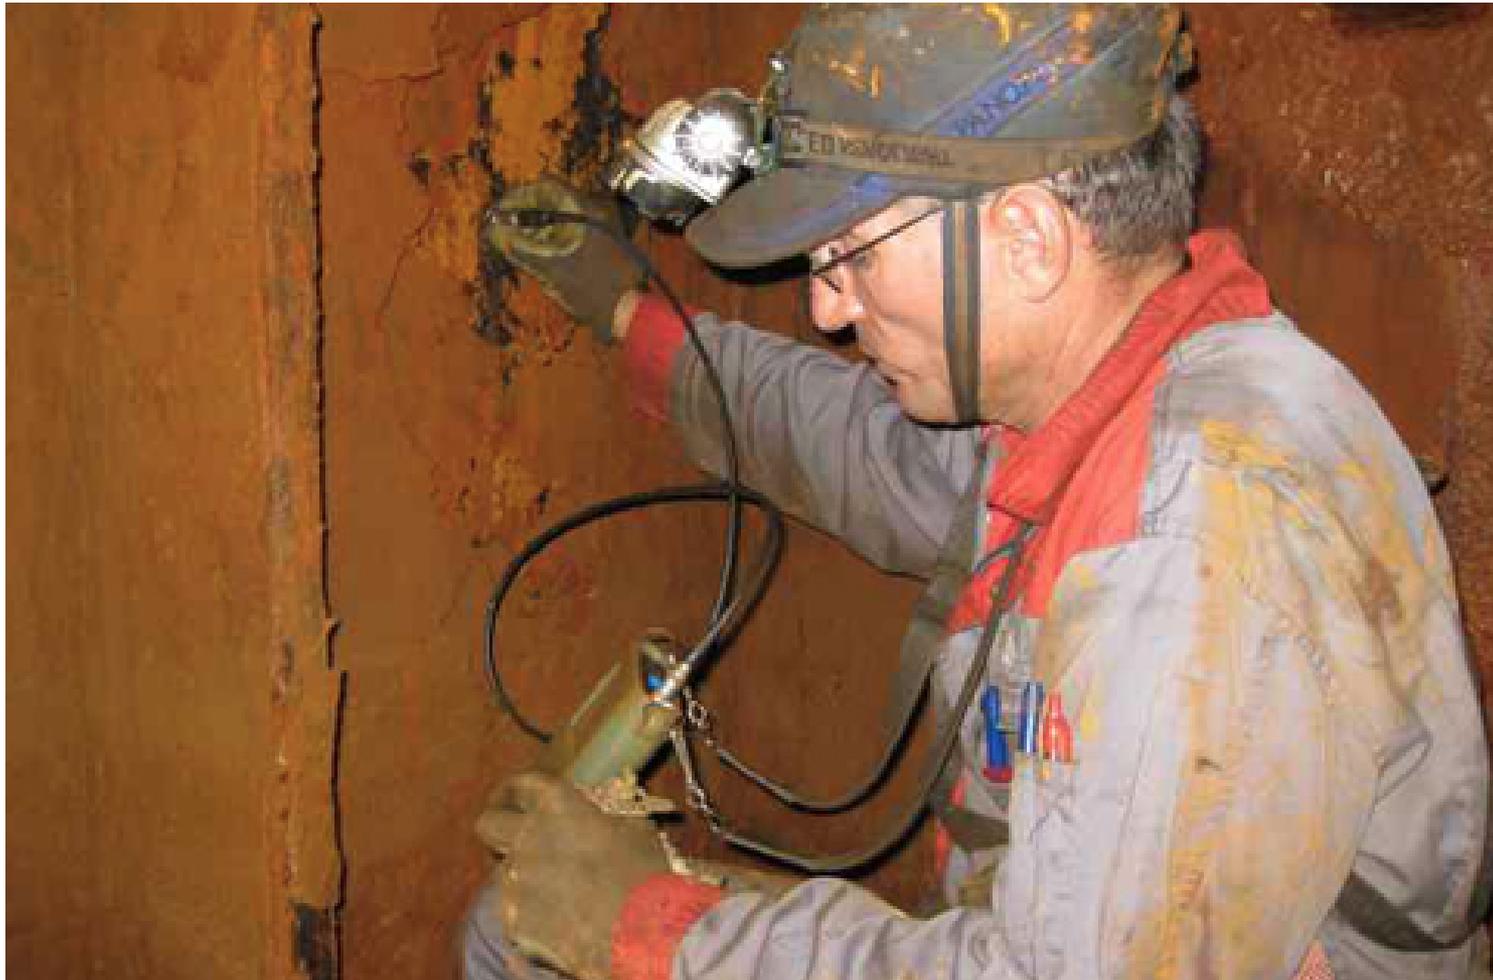
## UT Gauging

**Ultrasonic thickness (UT) gauging techniques**, other NDT techniques (DP, X-ray etc).

The thickness is measured using the velocity of the sound through the material (standard frequency used is 5Hz).

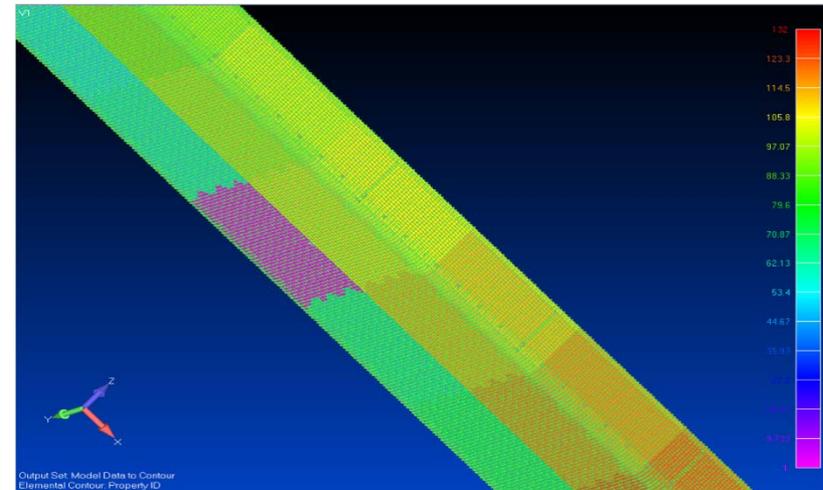
Modelling carried out based on the net scantlings,

$\text{Net}^* = \text{Measured Thickness} - \text{Corrosion Allowance}$

Different thickness in different locations.

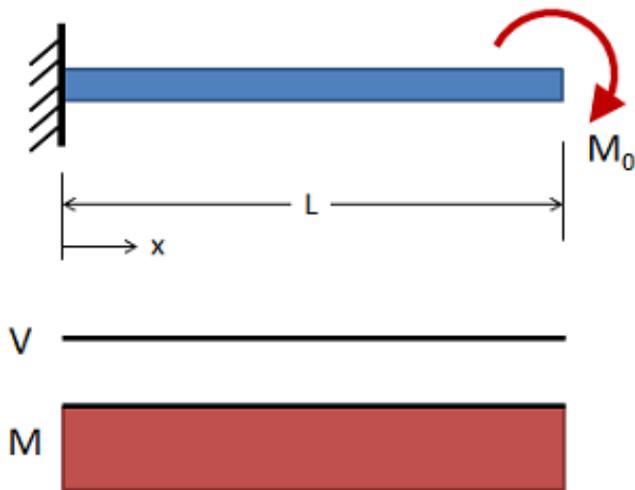
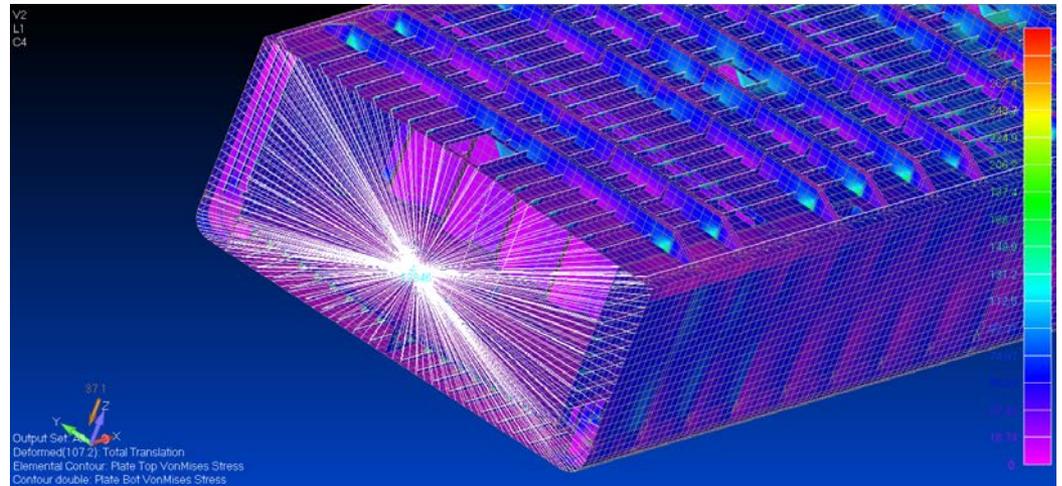
# Boundary Conditions; Case 1

Cantilever Beam applied with Design Bending Moment.

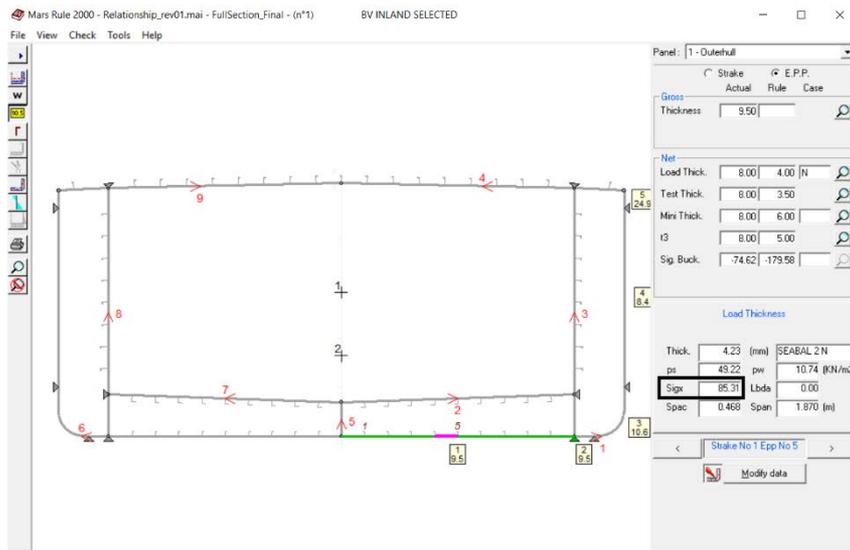
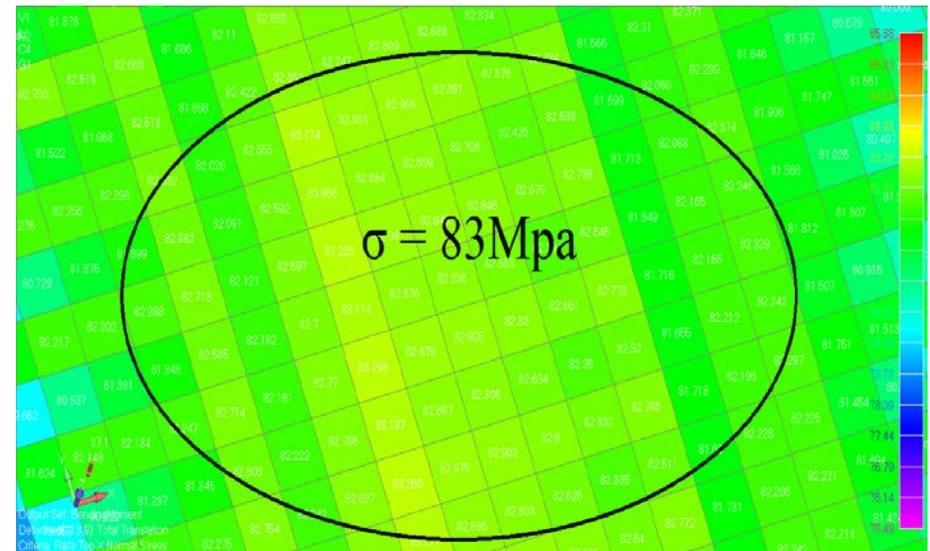
# Hull Girder Stresses; Bottom Plating (Sagging Case)

Compared between the Mars Model and the FE Model (Midship),

MarsInland (Mpa)	FEM (Mpa)	% Difference
85.31	83	2.7

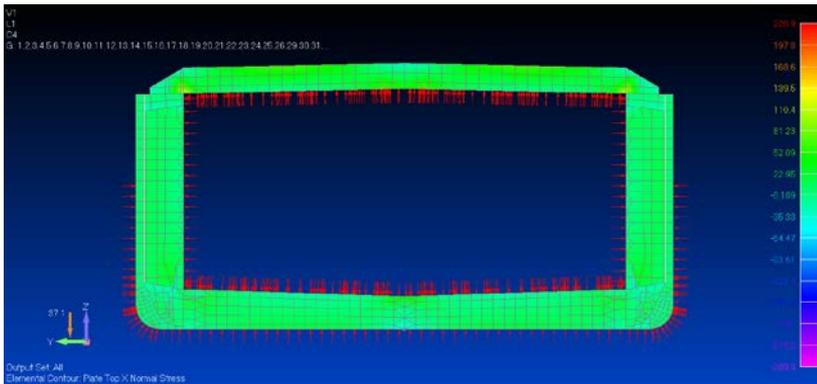
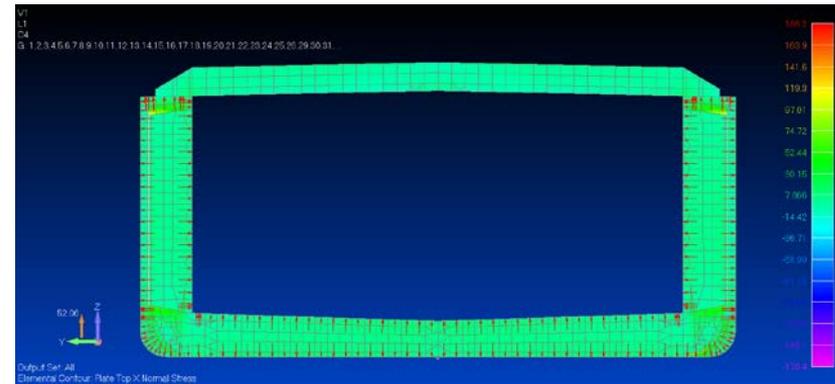
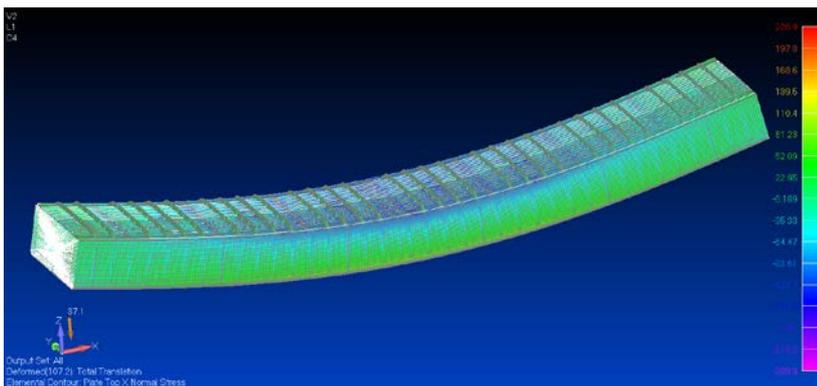
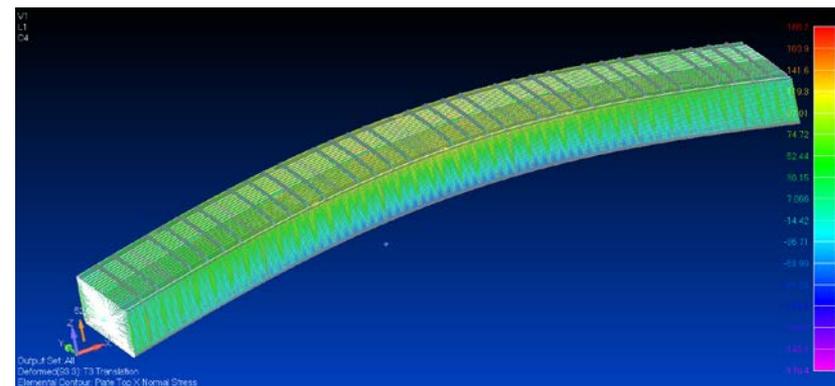
# Boundary Conditions; Case 2

## Simply Supported Beam Applied with Local Loads

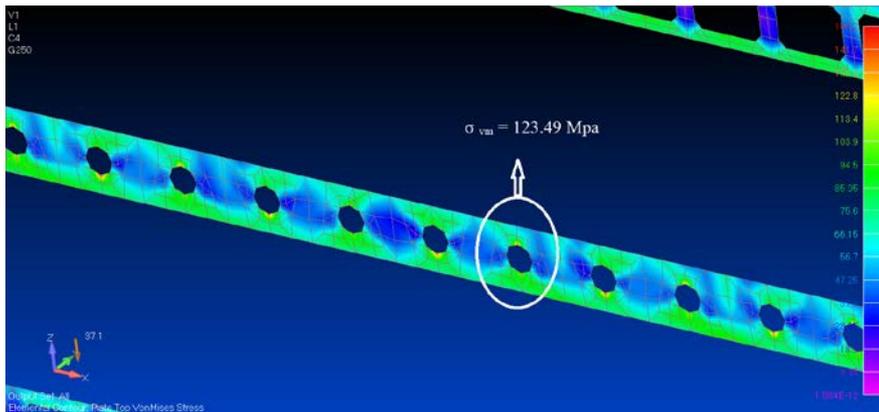
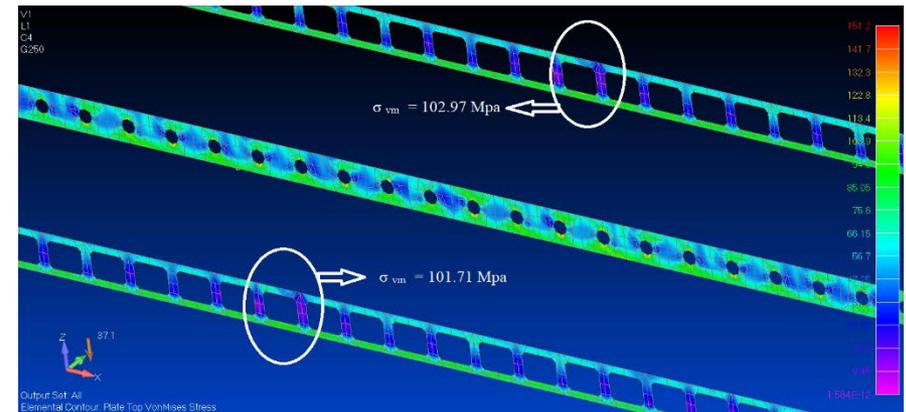
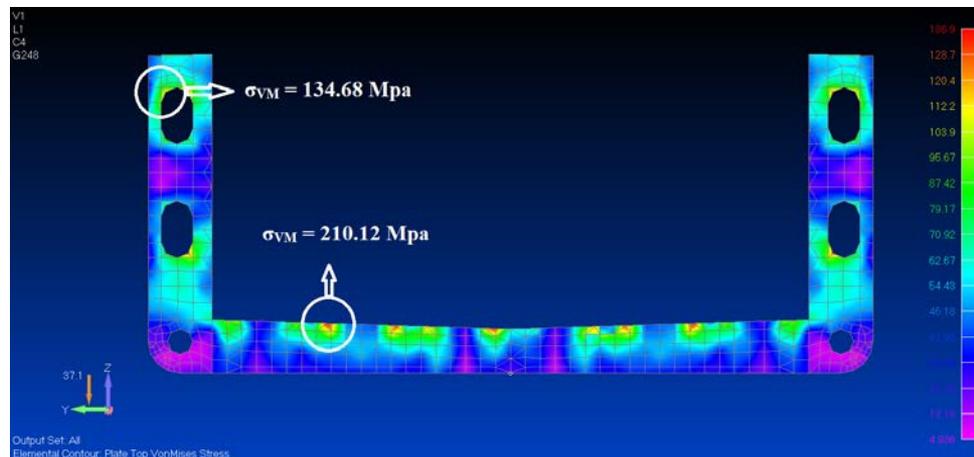
## Results; Von-Mises Stress

Severe in Fully-Loaded Case (Test Pressure applied = 65kpa).

Von-mises Stresses are within the Limits;  $\sigma_{VM} \leq \sigma_{MASTER}$  (219.42 Mpa)

For primary supporting members and transverse frames, the strength analysis using FEA gives a maximum von-mises stress of  $210.12 \text{ N/mm}^2$ , which can be considered as acceptable. (Permissible von-mises stress is  $219.42 \text{ N/mm}^2$  ),

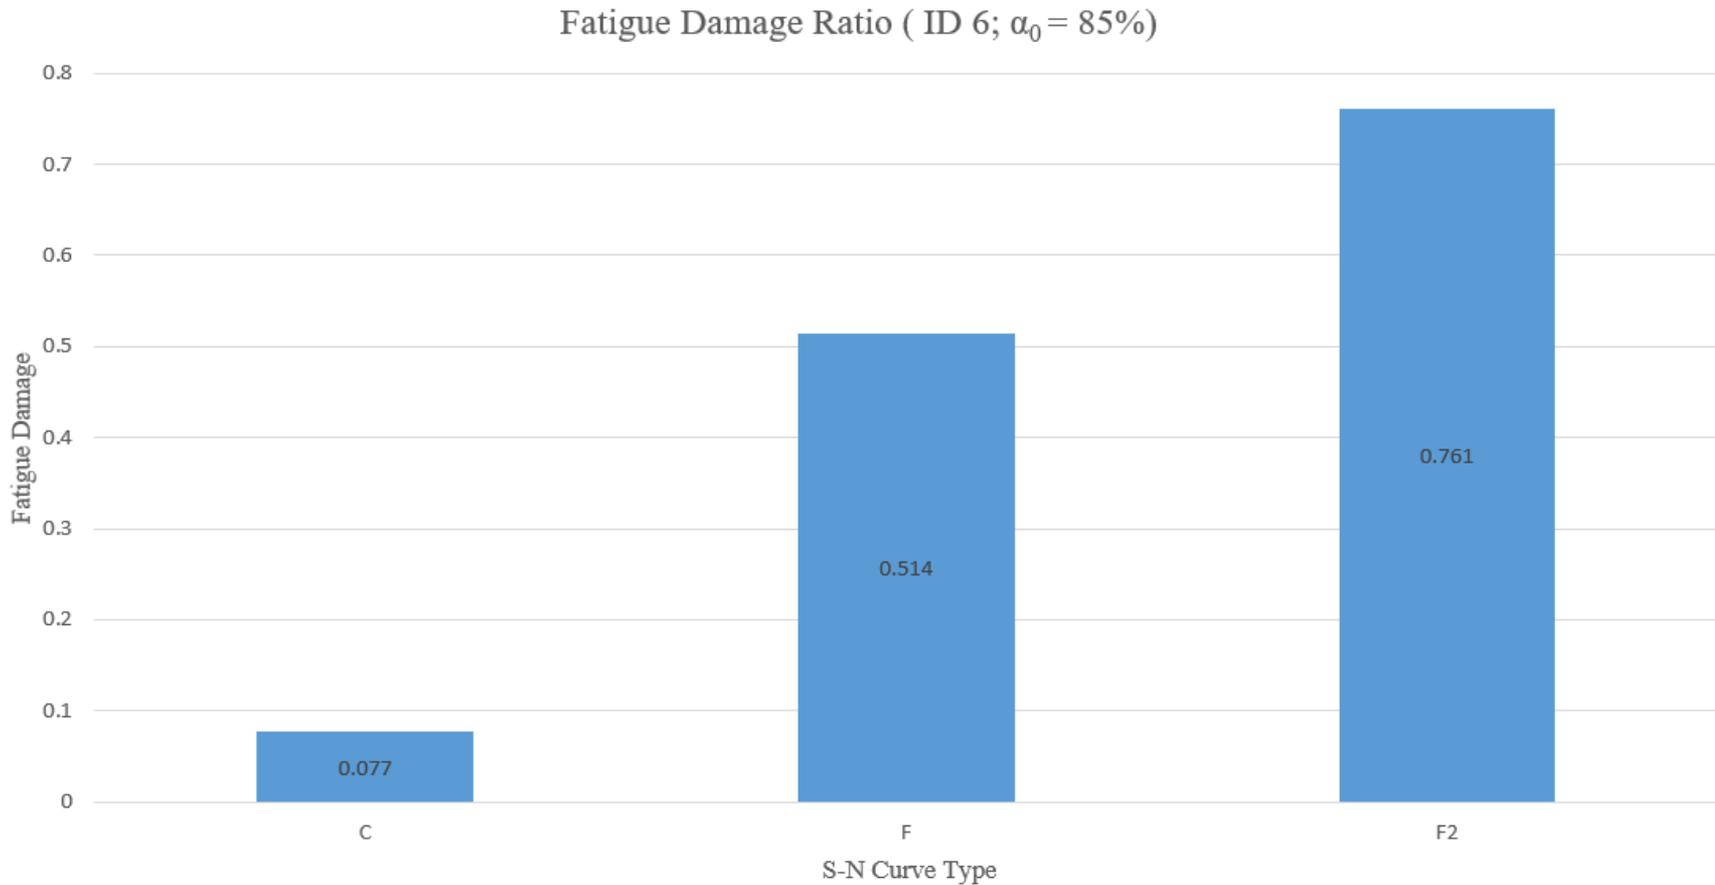
# Fatigue Damage Ratio of Critical Detail For Various S-N Curve

Fatigue damage directly related to the wave height. The Inland vessel encounters max. wave height of 1.2m does not induce Fatigue damage.

The most conservative results are obtained with type F2 curves (with lower  $S_q$  values).
